## TEST REPORT

### LZM02-02513/22/Z00NZM

ALBOND FR

ALBOND 9000 A2

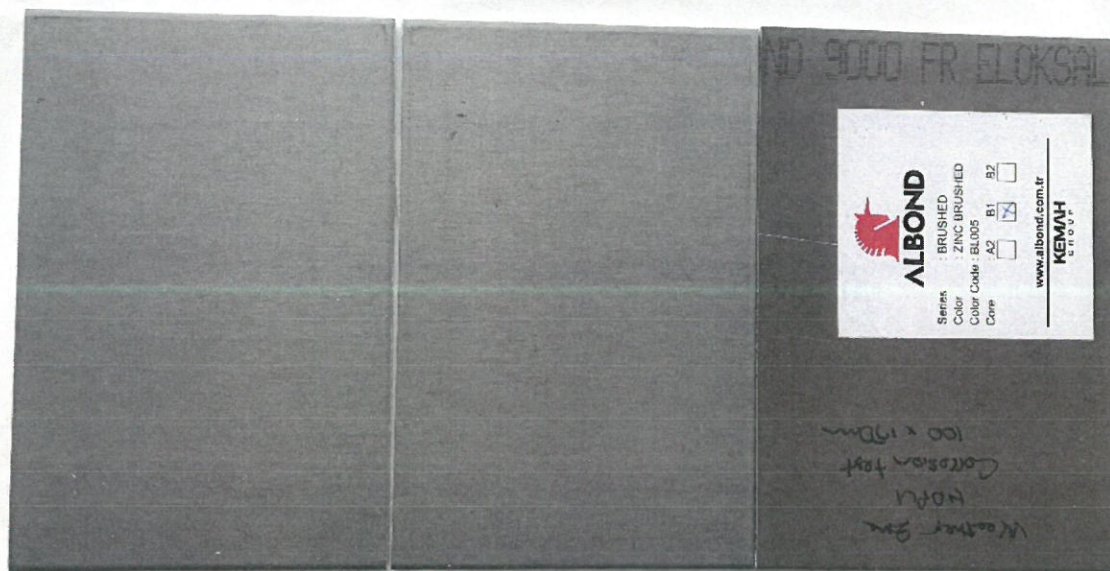
Photo 1. HDPU coating.

Aluminium sheet samples with dimensions 100x150 mm and composite panels with technological cutter (photo 1).
